<b>IN RE: ETHICON, INC., PELVIC REPAIR SYSTEM PRODUCTS LIABILITY LITIGATION</b>	<b>Master File No. 2:12-MD-02327 MDL 2327</b>  <b>JOSEPH R. GOODWIN U.S. DISTRICT JUDGE</b>
<b>THIS DOCUMENT RELATES TO:</b>  <i>Wave 1 Cases</i>

**Intentional Oxidation of Prolene Mesh – Part 2**

**Supplemental Report of Dr. Shelby F. Thames**

**September 28, 2016**

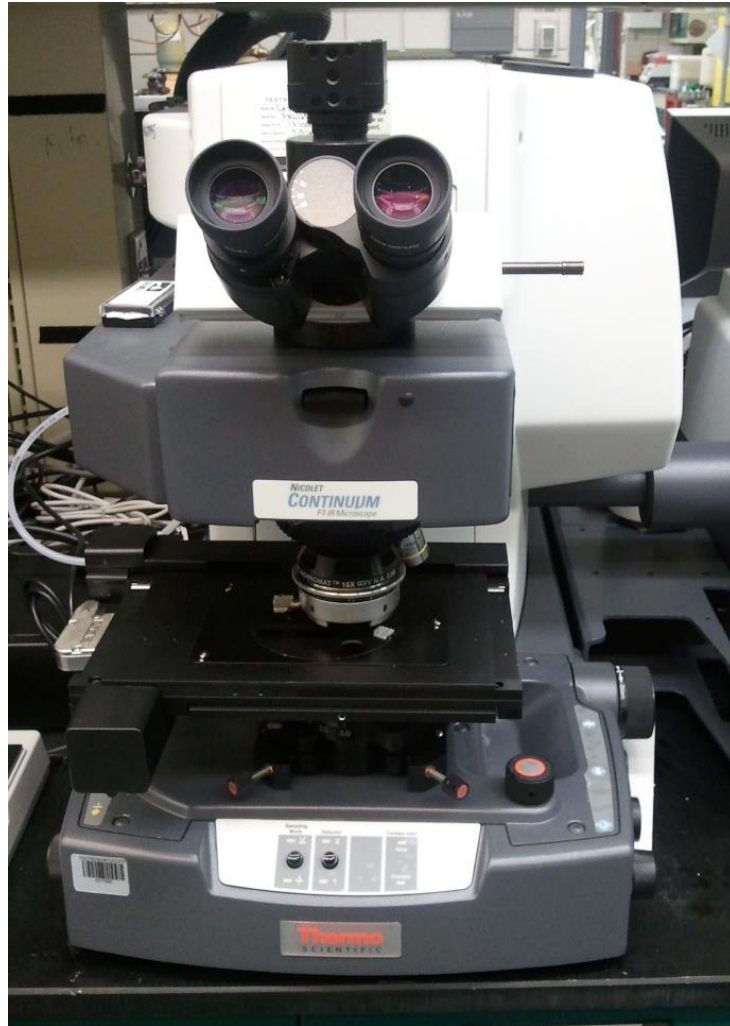
**Figure 5. Thermo-Nicolet Continuum FTIR Microscope**

The pristine TVT exemplar sample was characterized via Fourier Transform Infrared Microscopy (FTIR) with a Thermo-Nicolet Continuum FTIR Microscope (Figure 5) prior to UV exposure. The resulting spectrum (Figure 6) contains an inset image showing the penetrating IR beam location. The absorption frequency at  $1742\text{ cm}^{-1}$ , indicative of Ethicon's DLTDP antioxidant, is also noted in my previous reports, which I rely upon, and is present in the spectrum.

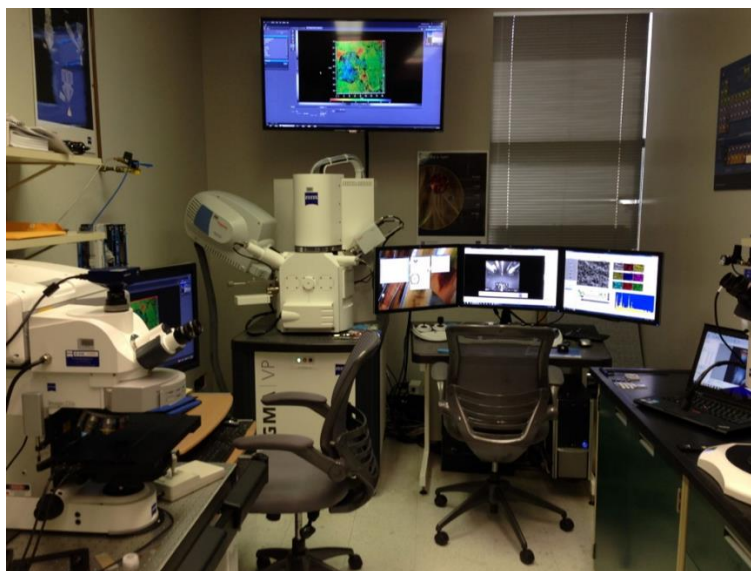
**Figure 10. Zeiss Sigma VP FEG-SEM**

Digital microscopy and scanning electron microscopy (SEM) of the before and after fiber exposure samples were conducted with a Keyence VHX-600 digital microscope (Figure 9) and a Zeiss Sigma VP FEG-SEM (Figure 10). One can readily observe oxidation effects upon Prolene as demonstrated by light microscopy and SEM fiber images (Figures 11 and 12, respectfully); before and after UV exposure. As a result of UV exposure, as described herein, Prolene fibers were grossly embrittled and demonstrated deep cracks resulting in fiber rupture via crack propagation.
